Feather River, RM 28.5R (LM 14.5, Sutter County LD 1 West)

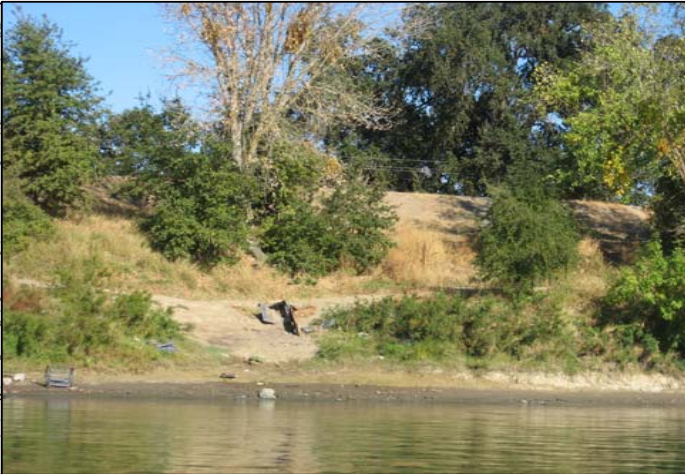
Site Photograph

Criteria	Score	Notes
Bank Slope (*2)	1	2.5:1 slope
Berm Width (*2) - Estimated	2	15 ft
Location of erosion	3	toe
Bank Stability	0	no vertical sections or caves
Site Relative to Bend	1	straight
Vegetation Cover	1	80%
Tree Hazard	3	large trees
Soil Type (*2)	4	sands and silts
Velocity (*2)	3	4.89 ft/s
Human Usage	5	daily, road and lots of human debris
Erosion Hazard	33	Calculate Erosion Hazard

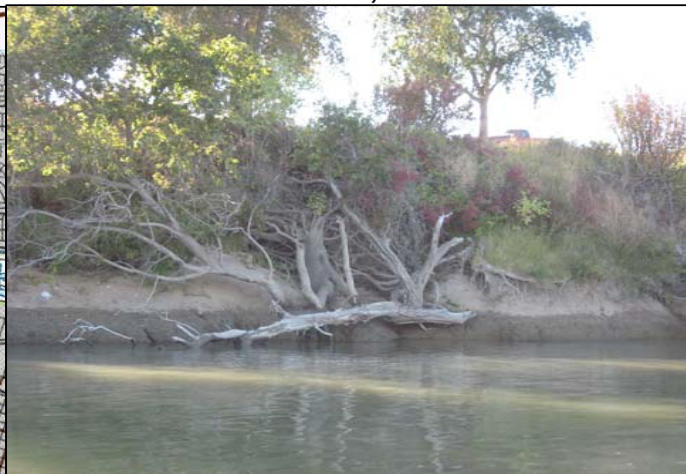
Site Photograph

Criteria	Score	Notes
Bank Slope (*2)	3	1.5:1 slope
Berm Width (*2) - Estimated	2	less than 20 ft
Location of erosion	3	toe
Bank Stability	2	vertical sections, less than halfbank height
Site Relative to Bend	1	straight
Vegetation Cover	1	80%
Tree Hazard	4	large trees with exposed roots
Soil Type (*2)	2	clays and silts
Velocity (*2)	3	3.08 ft/s
Human Usage	2	heavy veg, seasonal
Erosion Hazard	33	Calculate Erosion Hazard

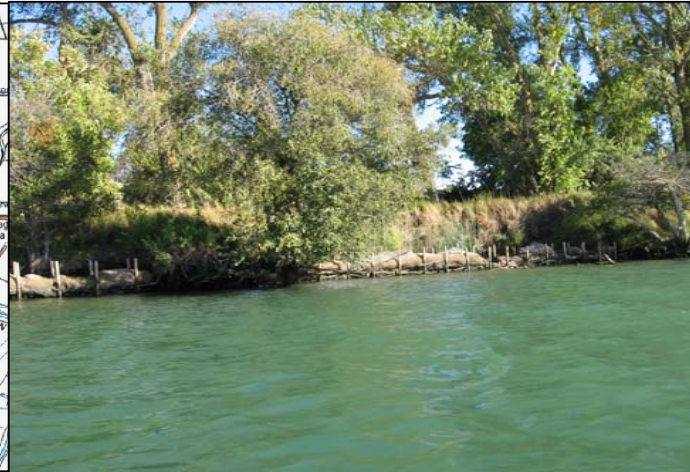
Site Photograph

Criteria	Score	Notes
Bank Slope (*2)	3	2:1 slope
Berm Width (*2) - Estimated	0	30 to 50 ft
Location of erosion	4	berm and toe
Bank Stability	2	short vertical sections
Site Relative to Bend	1	straight
Vegetation Cover	0	80 - 90%
Tree Hazard	4	large trees, exposed roots
Soil Type (*2)	4	sands and silts
Velocity (*2)	3	4.16 ft/s
Human Usage	2	seasonal
Erosion Hazard	33	Calculate Erosion Hazard

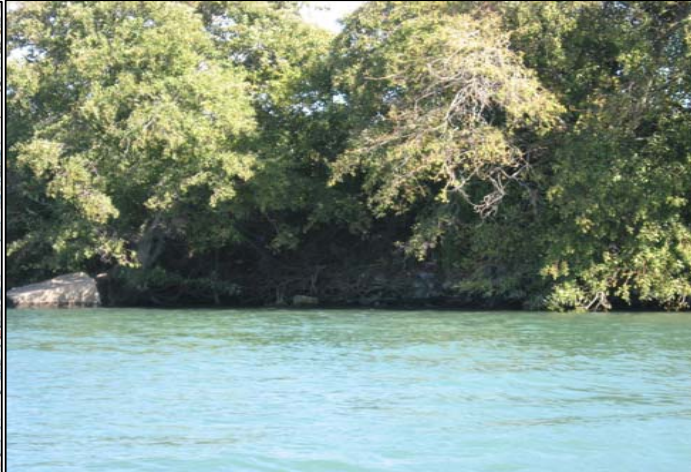
Site Photograph

Criteria	Score	Notes
Bank Slope (*2)	3	1.5:1 slope
Berm Width (*2) - Estimated	2	15 ft
Location of erosion	1	levee slope
Bank Stability	2	short vertical sections
Site Relative to Bend	1	straight
Vegetation Cover	0	95%
Tree Hazard	3	large trees
Soil Type (*2)	4	sands and silts
Velocity (*2)	3	3.77 ft/s
Human Usage	2	seasonal
Erosion Hazard	33	Calculate Erosion Hazard

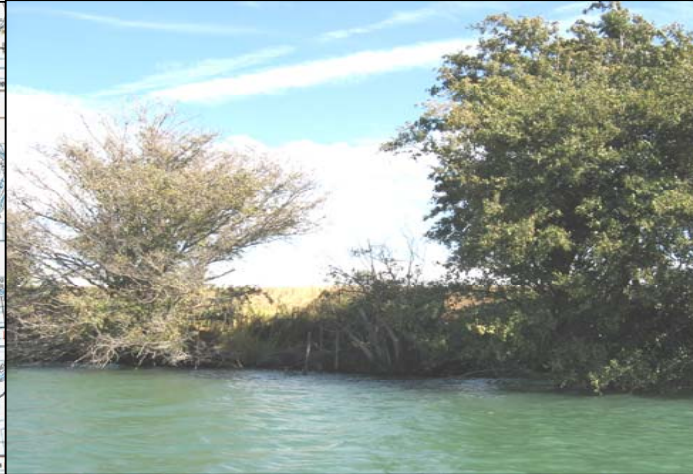
Site Photograph

Criteria	Score	Notes
Bank Slope (*2)	3	1.5:1 slope
Berm Width (*2) - Estimated	4	less than 5 ft of berm
Location of erosion	3	toe
Bank Stability	0	no vertical sections or beaver burrows
Site Relative to Bend	1	straight
Vegetation Cover	0	90%
Tree Hazard	0	no trees
Soil Type (*2)	4	sands and silts
Velocity (*2)	3	4.02 ft/s
Human Usage	1	occassional
Erosion Hazard	33	Calculate Erosion Hazard

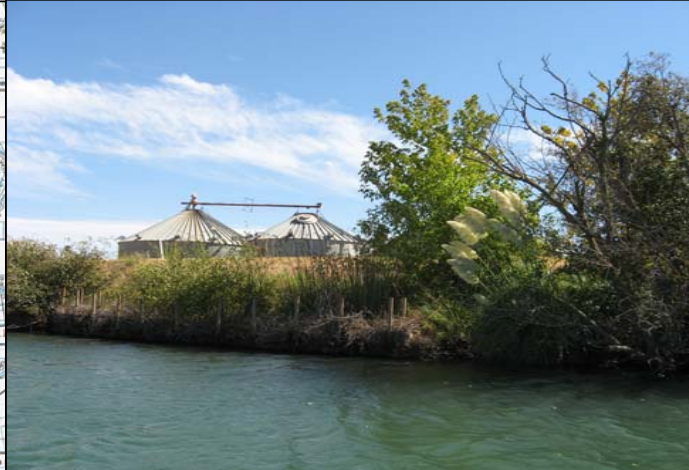
Site Photograph

Criteria	Score	Notes
Bank Slope (*2)	2	2:1 slope
Berm Width (*2) - Estimated	4	less than 5 ft
Location of erosion	3	toe
Bank Stability	1	some erosion pockets
Site Relative to Bend	0	inside of a bend
Vegetation Cover	1	70% cover
Tree Hazard	1	young trees
Soil Type (*2)	4	sands and silts
Velocity (*2)	3	4.04 ft/s
Human Usage	1	adjacent to private property, occassional
Erosion Hazard	33	Calculate Erosion Hazard

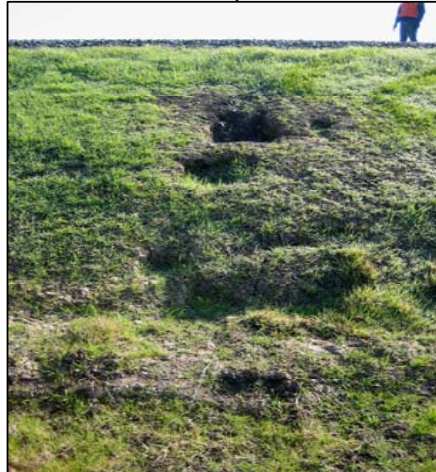
Site Photograph

Criteria	Score	Notes
Bank Slope (*2)	1	2.5:1 slope
Berm Width (*2) - Estimated	5	no berm
Location of erosion	4	toe and lower slope
Bank Stability	3	Piping holes greater than 4 ft
Site Relative to Bend	3	outside of slight bend
Vegetation Cover	0	grass covers 80 to 90%
Tree Hazard	0	no trees
Soil Type (*2)	2	silts and clays
Velocity (*2)	3	4 ft/s
Human Usage	1	occassional
Erosion Hazard	33	Calculate Erosion Hazard

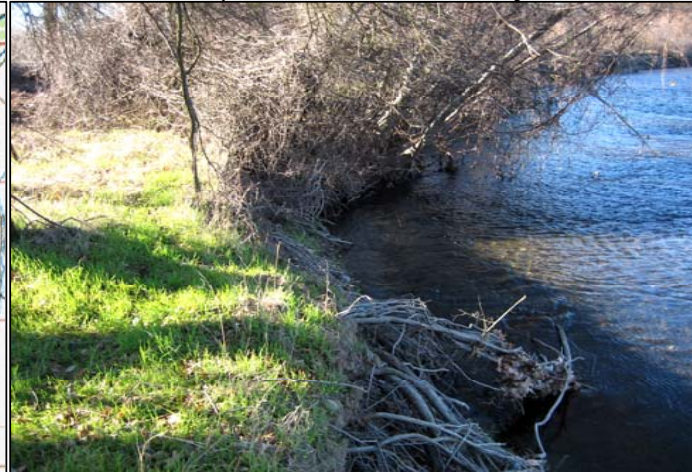
Site Photograph

Criteria	Score	Notes
Bank Slope (*2)	2	2:1 slope
Berm Width (*2) - Estimated	2	10 to 15 ft
Location of erosion	4	whole bank
Bank Stability	0	no vertical sections or caves
Site Relative to Bend	3	outside of a gentle bend
Vegetation Cover	1	80%
Tree Hazard	5	trees leaning, about to fall, roots exposed
Soil Type (*2)	3	sands and cobbles
Velocity (*2)	2	3 ft/s
Human Usage	2	seasonal
Erosion Hazard	33	Calculate Erosion Hazard

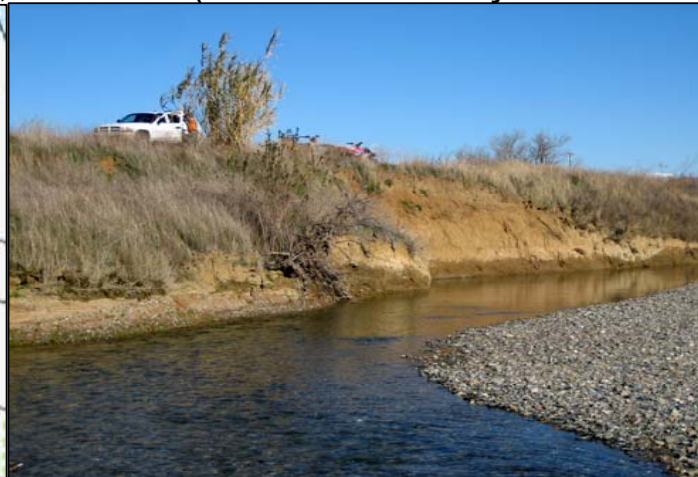
Site Photograph

Criteria	Score	Notes
Bank Slope (*2)	4	less than 1:1 slope
Berm Width (*2) - Estimated	1	25 to 30 ft
Location of erosion	5	whole bank and underwater
Bank Stability	5	vertical sections and animal burrows
Site Relative to Bend	1	straight
Vegetation Cover	2	60%
Tree Hazard	0	no trees
Soil Type (*2)	2	clays and silts
Velocity (*2)	2	3 ft/s
Human Usage	2	seasonal
Erosion Hazard	33	Calculate Erosion Hazard

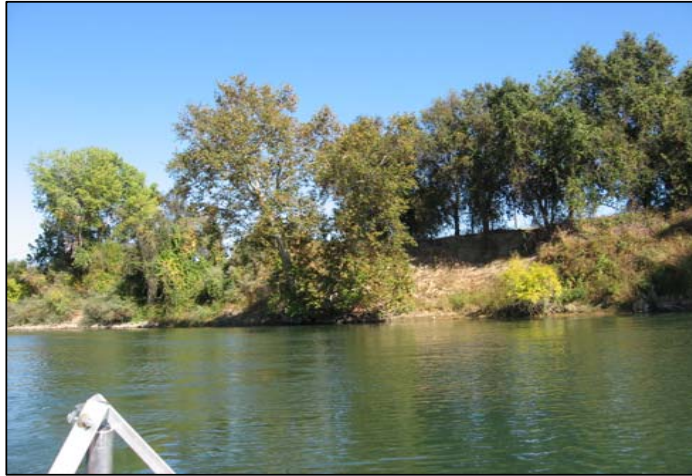
Site Photograph

Criteria	Score	Notes
Bank Slope (*2)	3	1.5:1 slope
Berm Width (*2) - Estimated	0	30 ft
Location of erosion	2	full bank
Bank Stability	5	vertical sections and caves
Site Relative to Bend	1	straight
Vegetation Cover	1	70%
Tree Hazard	5	large trees, leaning with exposed roots
Soil Type (*2)	2	clays and silts
Velocity (*2)	3	4.64 ft/s
Human Usage	2	seasonal
Erosion Hazard	32	Calculate Erosion Hazard

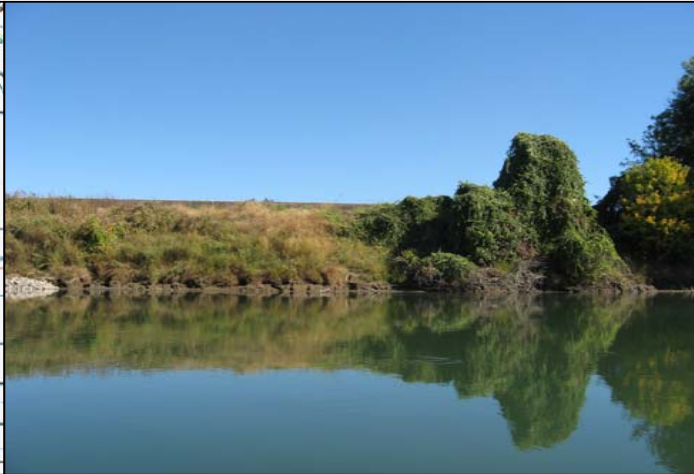
Site Photograph

Criteria	Score	Notes
Bank Slope (*2)	2	2:1 slope
Berm Width (*2) - Estimated	1	25 ft
Location of erosion	3	toe
Bank Stability	1	caves
Site Relative to Bend	2	just downstream of a bend
Vegetation Cover	3	40%
Tree Hazard	3	large trees
Soil Type (*2)	2	clays and silts
Velocity (*2)	4	5.04 ft/s
Human Usage	2	seasonal
Erosion Hazard	32	Calculate Erosion Hazard

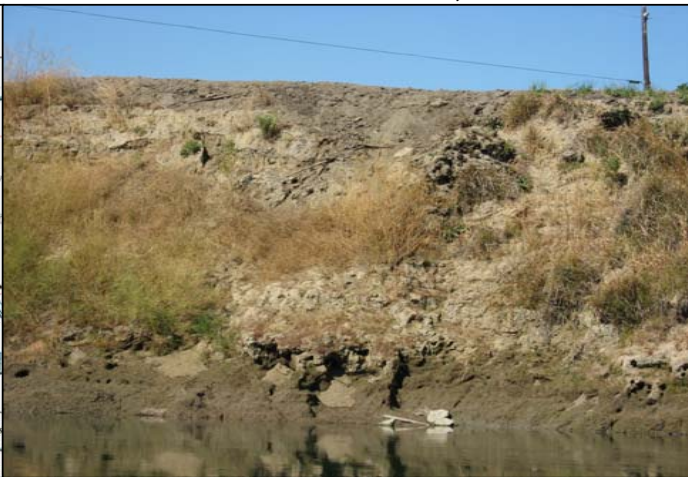
Site Photograph

Criteria	Score	Notes
Bank Slope (*2)	3	1.5:1 slope
Berm Width (*2) - Estimated	0	30 ft
Location of erosion	3	toe
Bank Stability	1	animal burrows
Site Relative to Bend	5	outside of a tight bend
Vegetation Cover	1	70%
Tree Hazard	0	no trees
Soil Type (*2)	4	sands and silts
Velocity (*2)	3	3.38 ft/s
Human Usage	2	seasonal
Erosion Hazard	32	Calculate Erosion Hazard

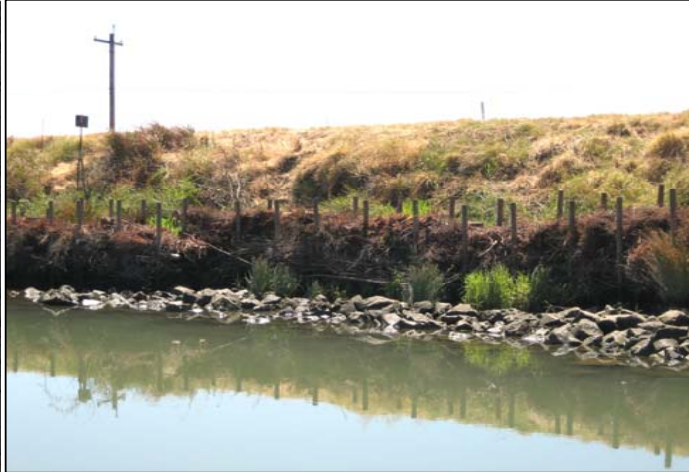
Site Photograph

Criteria	Score	Notes
Bank Slope (*2)	4	1:1 slope
Berm Width (*2) - Estimated	4	less than 5 ft
Location of erosion	0	levee
Bank Stability	0	no vertical sections or beaver burrows
Site Relative to Bend	0	inside of a bend
Vegetation Cover	1	about 70 to 80 %
Tree Hazard	0	no trees
Soil Type (*2)	4	sands and silts
Velocity (*2)	3	3.76 ft/s
Human Usage	1	occassional
Erosion Hazard	32	Calculate Erosion Hazard

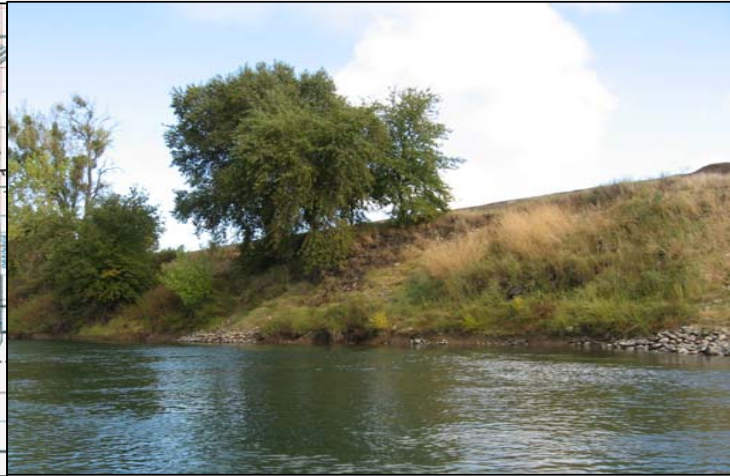
Site Photograph

Criteria	Score	Notes
Bank Slope (*2)	1	2.5:1 slope
Berm Width (*2) - Estimated	2	15 ft
Location of erosion	3	toe
Bank Stability	0	no vertical sections or caves/burrows
Site Relative to Bend	1	straight
Vegetation Cover	1	about 60 to 70%
Tree Hazard	4	large trees with visible roots
Soil Type (*2)	3	Sands
Velocity (*2)	3	4.8 ft/s
Human Usage	5	multiple paths seen down to river, daily usage
Erosion Hazard	32	Calculate Erosion Hazard

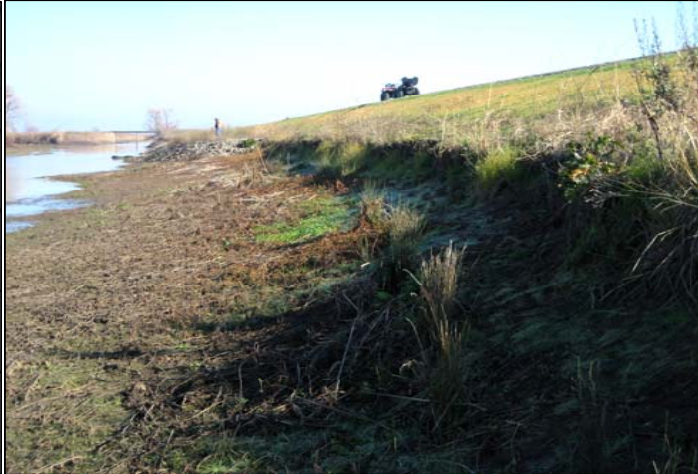
Site Photograph

Criteria	Score	Notes
Bank Slope (*2)	1	2.5:1 slope
Berm Width (*2) - Estimated	5	no berm
Location of erosion	3	toe
Bank Stability	2	vertical slope sections less than half bank height
Site Relative to Bend	1	straight
Vegetation Cover	1	grass and twigs, likely burned annually, 60% cover
Tree Hazard	0	no trees
Soil Type (*2)	2	silts and clays
Velocity (*2)	4	6 ft/s
Human Usage	1	occassional
Erosion Hazard	32	Calculate Erosion Hazard

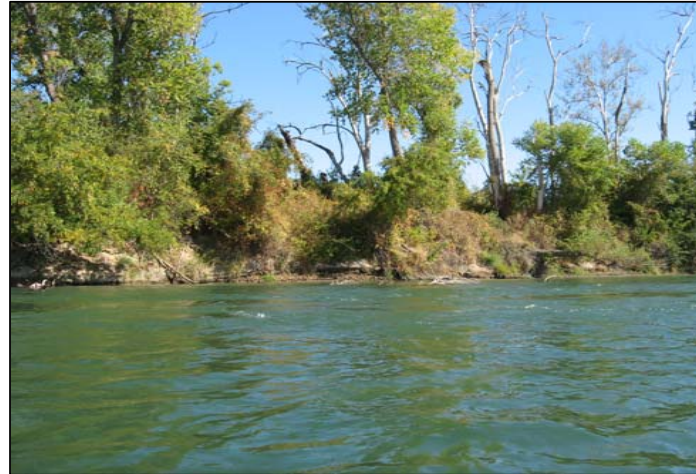
Site Photograph

Criteria	Score	Notes
Bank Slope (*2)	3	1.5:1 slope
Berm Width (*2) - Estimated	0	60 ft
Location of erosion	2	full bank
Bank Stability	2	vertical sections, less than half bank height
Site Relative to Bend	3	outside of a gentle bend
Vegetation Cover	0	80%
Tree Hazard	4	large trees with exposed roots
Soil Type (*2)	2	clays and silts
Velocity (*2)	5	10.07 ft/s
Human Usage	0	rare
Erosion Hazard	31	Calculate Erosion Hazard

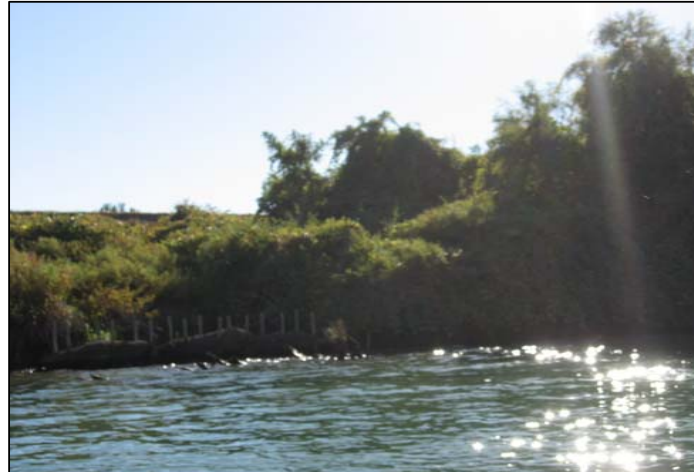
Site Photograph

Criteria	Score	Notes
Bank Slope (*2)	2	2:1 slope
Berm Width (*2) - Estimated	2	10 ft
Location of erosion	2	berm slope
Bank Stability	0	no vertical sections or caves
Site Relative to Bend	1	straight
Vegetation Cover	0	90%
Tree Hazard	3	large trees
Soil Type (*2)	4	sands and silts
Velocity (*2)	3	4.5 ft/s
Human Usage	3	monthly
Erosion Hazard	31	Calculate Erosion Hazard

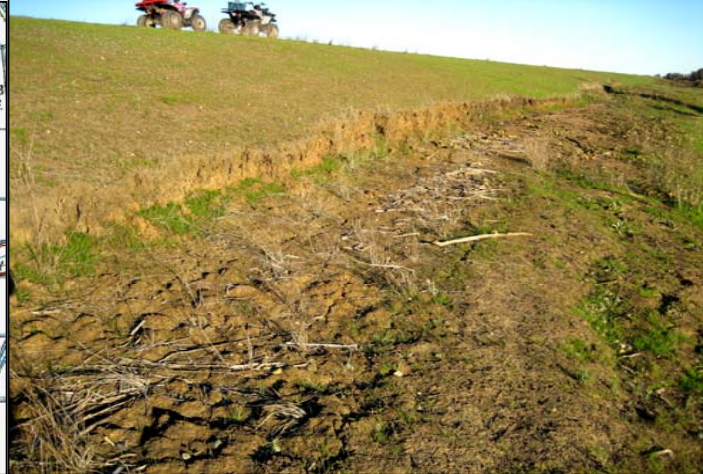
Willow Slough, LM 6.9 (DWR Unit 2 South)

Criteria	Score	Notes
Bank Slope (*2)	2	2:1 slope
Berm Width (*2) - Estimated	5	no berm
Location of erosion	2	lower levee slope
Bank Stability	2	vertical sections, less than half bank height
Site Relative to Bend	4	outside of a 90 degree bend
Vegetation Cover	3	poorly seeded grass
Tree Hazard	0	no trees
Soil Type (*2)	2	clays and silts
Velocity (*2)	0	0.2 ft/s
Human Usage	2	seasonal for duck hunting
Erosion Hazard	31	Calculate Erosion Hazard

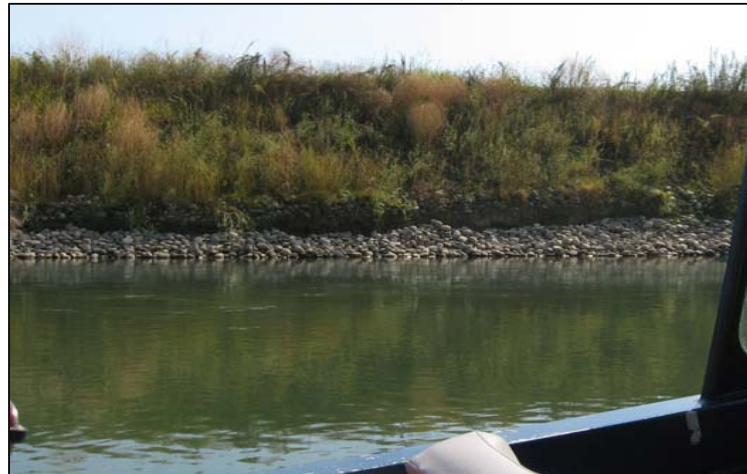
Sacramento River, RM 104.0L

Criteria	Score	Notes
Bank Slope (*2)	3	1.5:1 slope
Berm Width (*2) - Estimated	0	35 ft
Location of erosion	4	levee, and berm
Bank Stability	2	vertical sections, less than half bank height
Site Relative to Bend	4	outside of a 90 degree bend
Vegetation Cover	1	60% to 70%
Tree Hazard	0	no trees
Soil Type (*2)	4	sands and silts
Velocity (*2)	2	2.25 ft/s
Human Usage	1	occassional
Erosion Hazard	30	Calculate Erosion Hazard

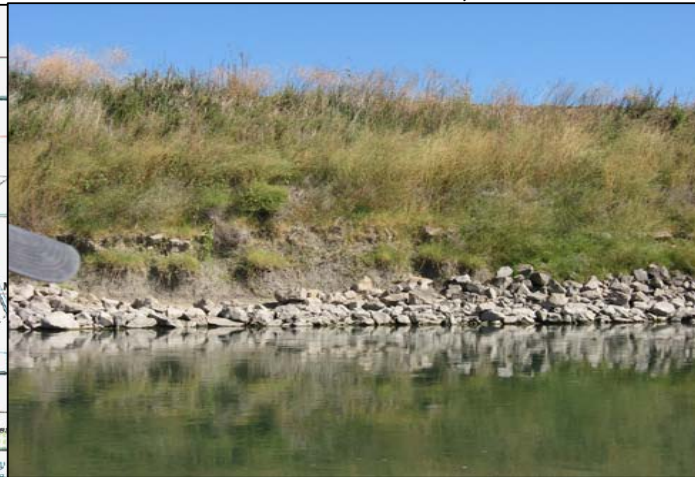
Sacramento River, RM 99.0L

Criteria	Score	Notes
Bank Slope (*2)	4	1:1 slope
Berm Width (*2) - Estimated	2	10 ft
Location of erosion	1	levee slope
Bank Stability	0	no vertical sections or caves
Site Relative to Bend	3	outside of a gentle bend
Vegetation Cover	1	60%
Tree Hazard	0	no trees
Soil Type (*2)	4	sands and silts
Velocity (*2)	2	2.72 ft/s
Human Usage	1	occassional
Erosion Hazard	30	Calculate Erosion Hazard

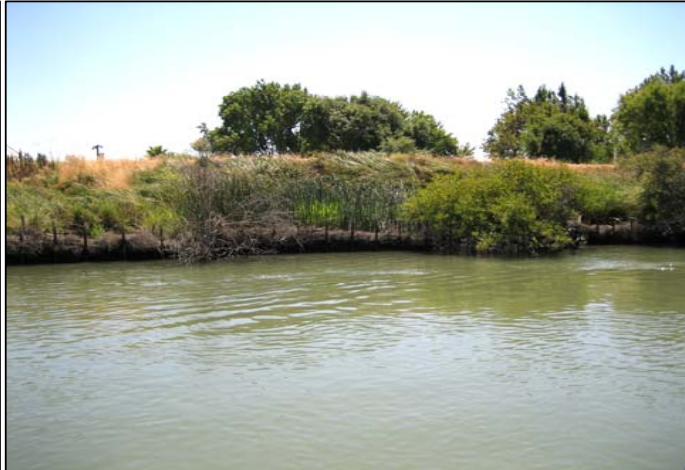
Georgiana Slough, RM 3.7L (a)

Criteria	Score	Notes
Bank Slope (*2)	2	2:1 slope
Berm Width (*2) - Estimated	4	less than 5 ft
Location of erosion	2	levee slope
Bank Stability	1	erosion pockets
Site Relative to Bend	0	inside of a bend
Vegetation Cover	0	90% cover
Tree Hazard	0	no trees
Soil Type (*2)	4	sands and silts
Velocity (*2)	3	4.04 ft/s
Human Usage	1	occasional
Erosion Hazard	30	Calculate Erosion Hazard

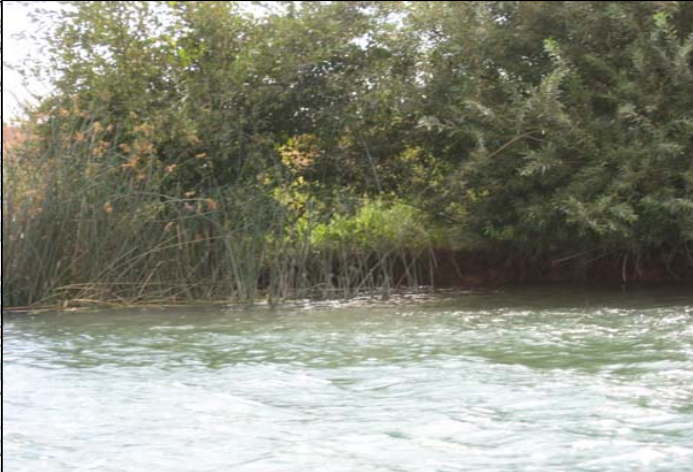
Georgiana Slough, RM 2.5L

Criteria	Score	Notes
Bank Slope (*2)	1	2.5:1 slope
Berm Width (*2) - Estimated	4	less than 5 ft
Location of erosion	3	toe
Bank Stability	2	some vertical sections, less than half the slope height
Site Relative to Bend	0	inside of a bend
Vegetation Cover	0	90%
Tree Hazard	0	small trees
Soil Type (*2)	4	sands and silts
Velocity (*2)	3	3.99 ft/s
Human Usage	1	occassional
Erosion Hazard	30	Calculate Erosion Hazard

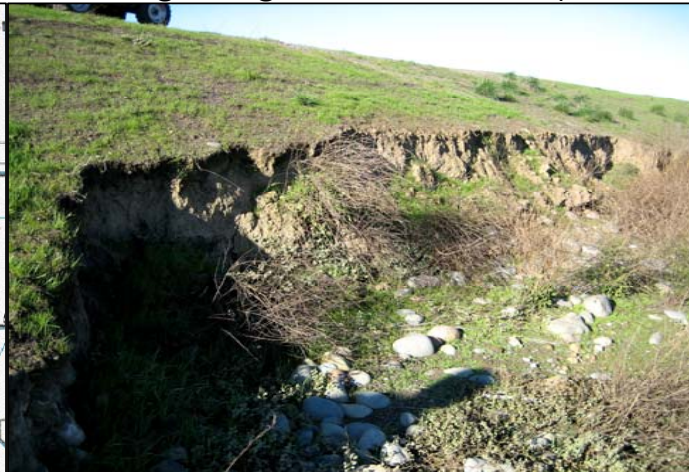
Knights Landing Ridge Cut, LM 0.2 (KLRD Unit 1 West)

Criteria	Score	Notes
Bank Slope (*2)	2	2:1 slope
Berm Width (*2) - Estimated	5	no berm
Location of erosion	4	toe and lower slope
Bank Stability	4	vertical sections, about half bank height
Site Relative to Bend	1	relatively straight
Vegetation Cover	3	40% or slightly more, likely burned annually
Tree Hazard	0	no trees
Soil Type (*2)	2	clays and silts
Velocity (*2)	0	0.1 ft/s
Human Usage	0	rare, no public access
Erosion Hazard	30	Calculate Erosion Hazard

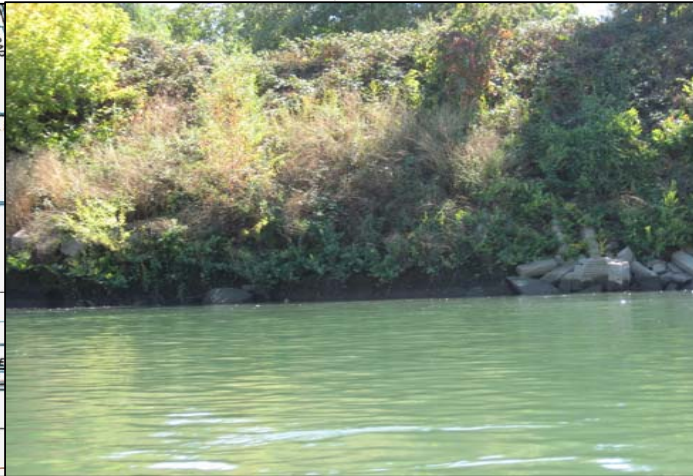
Sacramento River, RM 123.7R

Criteria	Score	Notes
Bank Slope (*2)	4	1:1 slope
Berm Width (*2) - Estimated	2	15 ft
Location of erosion	3	toe
Bank Stability	0	no vertical sections or caves
Site Relative to Bend	2	just downstream from a bend
Vegetation Cover	0	80 to 90%
Tree Hazard	0	no trees
Soil Type (*2)	2	clays and silts
Velocity (*2)	4	5.3 ft/s
Human Usage	0	rare
Erosion Hazard	29	Calculate Erosion Hazard

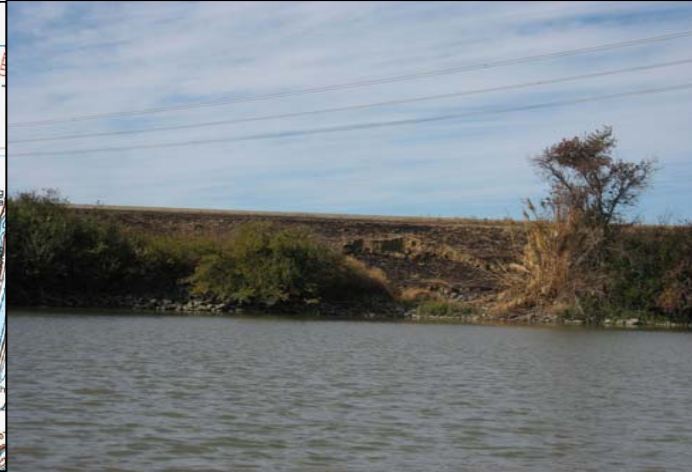
Cache Slough, RM 22.8R

Criteria	Score	Notes
Bank Slope (*2)	1	2.5:1 slope
Berm Width (*2) - Estimated	5	no berm
Location of erosion	4	mid-lower bank and toe
Bank Stability	2	vertical sections, less than half bank height
Site Relative to Bend	1	straight
Vegetation Cover	2	40%
Tree Hazard	0	small trees
Soil Type (*2)	2	clays and silts
Velocity (*2)	0	less than a 1ft/s
Human Usage	4	weekly, human debris and path
Erosion Hazard	29	Calculate Erosion Hazard

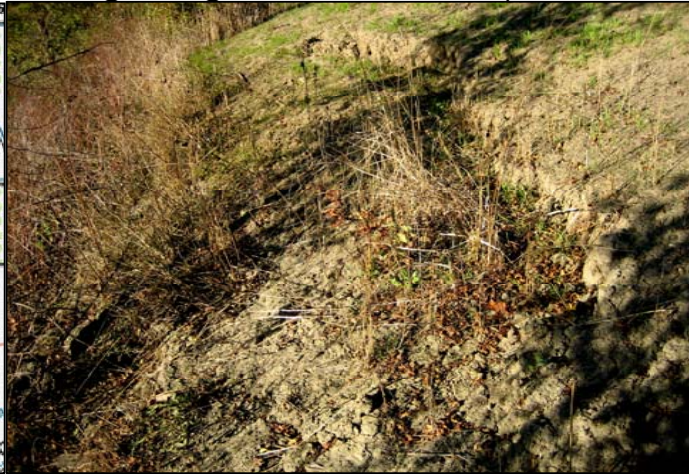
Knights Landing Ridge Cut, LM 4.3 (KLRD Unit 2 East)

Criteria	Score	Notes
Bank Slope (*2)	2	2:1 slope
Berm Width (*2) - Estimated	5	no berm
Location of erosion	4	toe and lower slope
Bank Stability	2	vertical sections, less than half bank height
Site Relative to Bend	1	relatively straight
Vegetation Cover	2	50 to 60%
Tree Hazard	1	young trees
Soil Type (*2)	2	silts with some clay
Velocity (*2)	0	0.1 ft/s
Human Usage	1	occassional, no access but close to town
Erosion Hazard	29	Calculate Erosion Hazard

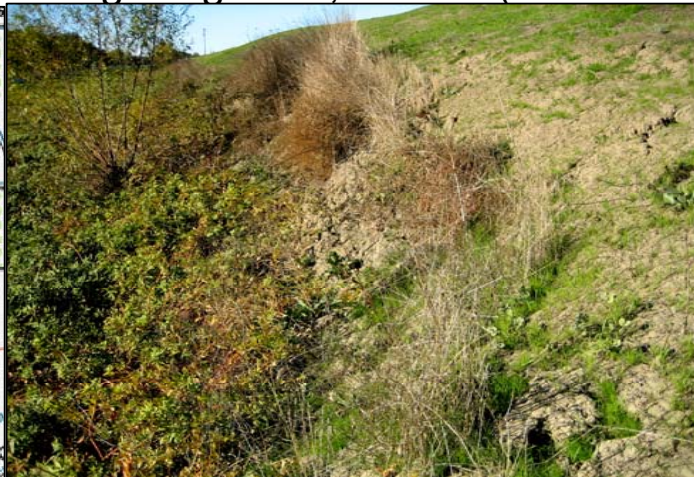
Knights Landing Ridge Cut, LM 5.3 (KLRD Unit 2 East)

Criteria	Score	Notes
Bank Slope (*2)	2	2:1 slope
Berm Width (*2) - Estimated	5	0 to 5 ft of berm
Location of erosion	4	toe and lower slope
Bank Stability	2	6 to 8 ft of vertical slope in sections
Site Relative to Bend	1	straight
Vegetation Cover	1	burned annually, 70%
Tree Hazard	1	small trees
Soil Type (*2)	2	clays and silts
Velocity (*2)	0	0.1 ft/s
Human Usage	1	occassional, no access but close to town
Erosion Hazard	28	Calculate Erosion Hazard

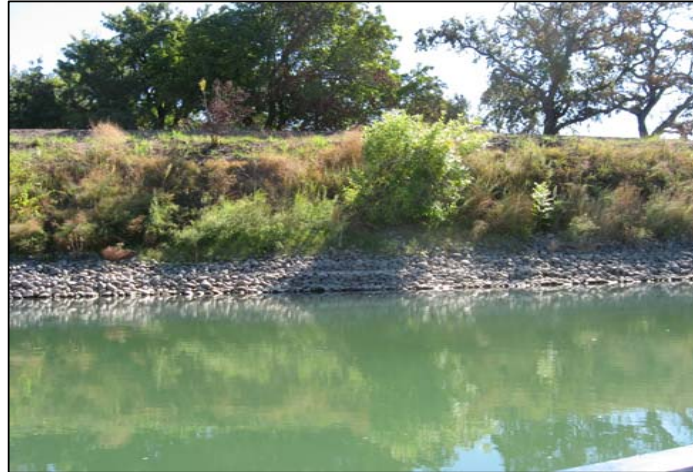
Sacramento River, RM 133.8L

Criteria	Score	Notes
Bank Slope (*2)	3	1.5:1 slope
Berm Width (*2) - Estimated	1	more than 20 ft of berm
Location of erosion	2	lower bank
Bank Stability	2	vertical sections less than half bank height
Site Relative to Bend	4	outside of a 90 degree bend
Vegetation Cover	1	80%
Tree Hazard	0	no trees
Soil Type (*2)	1	clays and rounded stone
Velocity (*2)	3	4.9 ft/s
Human Usage	2	adjacent to town, seasonal
Erosion Hazard	27	Calculate Erosion Hazard

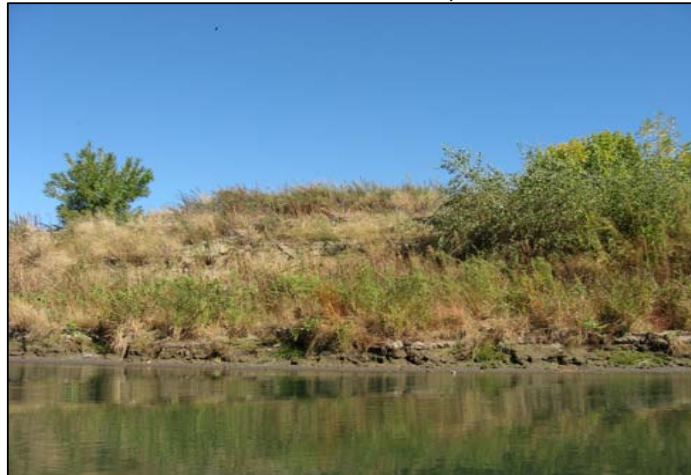
Sacramento River, RM 132.9R

Criteria	Score	Notes
Bank Slope (*2)	1	2.5:1 slope
Berm Width (*2) - Estimated	0	30 ft
Location of erosion	2	full bank
Bank Stability	2	small vertical sections
Site Relative to Bend	5	outside of a less than 90 degree bend
Vegetation Cover	3	40%
Tree Hazard	1	young trees
Soil Type (*2)	2	clays and silts
Velocity (*2)	3	4.97 ft/s
Human Usage	2	seasonal
Erosion Hazard	27	Calculate Erosion Hazard

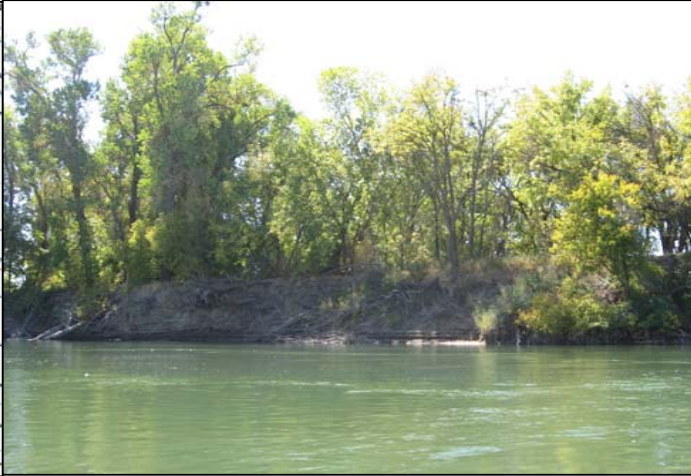
Sacramento River, RM 127.9R

Criteria	Score	Notes
Bank Slope (*2)	2	2:1 slope
Berm Width (*2) - Estimated	0	35 ft
Location of erosion	4	bank and toe
Bank Stability	2	vertical at toe
Site Relative to Bend	3	outside of a gentle bend
Vegetation Cover	2	40%
Tree Hazard	3	large trees
Soil Type (*2)	2	clays and silts
Velocity (*2)	2	2.92 ft/s
Human Usage	1	occassioanl
Erosion Hazard	27	Calculate Erosion Hazard

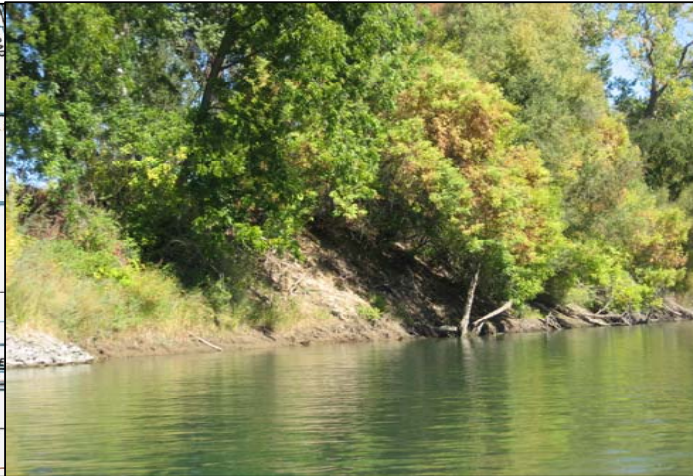
Sacramento River, RM 123.3L

Criteria	Score	Notes
Bank Slope (*2)	2	2:1 slope
Berm Width (*2) - Estimated	0	30 ft
Location of erosion	4	full bank and toe
Bank Stability	0	no vertical sections or caves
Site Relative to Bend	1	straight
Vegetation Cover	2	40%
Tree Hazard	4	large trees with exposed roots
Soil Type (*2)	2	clays and silts
Velocity (*2)	3	4.82 dt/s
Human Usage	2	seasonal
Erosion Hazard	27	Calculate Erosion Hazard

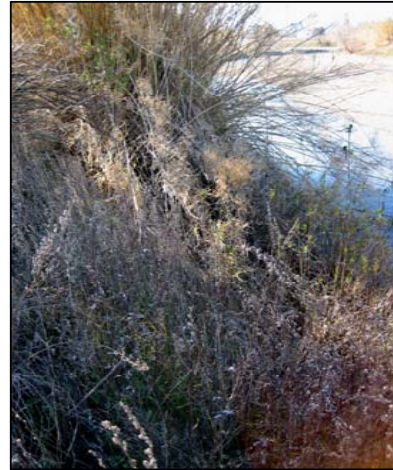
Elder Creek, LM 3.0 (Tehama County Unit 2 South)

Criteria	Score	Notes
Bank Slope (*2)	3	1.5:1 slope
Berm Width (*2) - Estimated	1	25 to 30 ft
Location of erosion	4	whole bank
Bank Stability	0	no holes or vertical sections
Site Relative to Bend	5	outside of a tight bend
Vegetation Cover	0	80%
Tree Hazard	0	small trees
Soil Type (*2)	2	clays and silts
Velocity (*2)	2	3 ft/s
Human Usage	2	seasonal
Erosion Hazard	27	Calculate Erosion Hazard

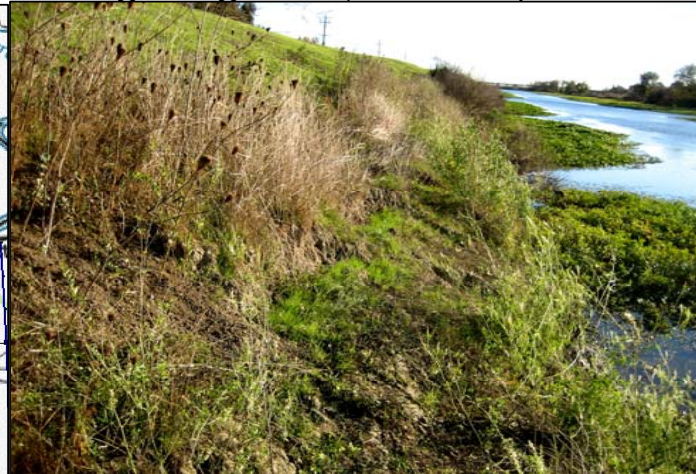
Knights Landing Ridge Cut, LM 3.0 (KLRD Unit 2 East)

Criteria	Score	Notes
Bank Slope (*2)	2	2:1 slope
Berm Width (*2) - Estimated	5	no berm
Location of erosion	4	toe and lower bank slope
Bank Stability	0	no vertical sections or caves
Site Relative to Bend	3	outside of a slight bend
Vegetation Cover	0	80% + cover
Tree Hazard	1	young trees
Soil Type (*2)	2	silts with some clays
Velocity (*2)	0	0.1 ft/s
Human Usage	1	occassional, no access but near town
Erosion Hazard	27	Calculate Erosion Hazard

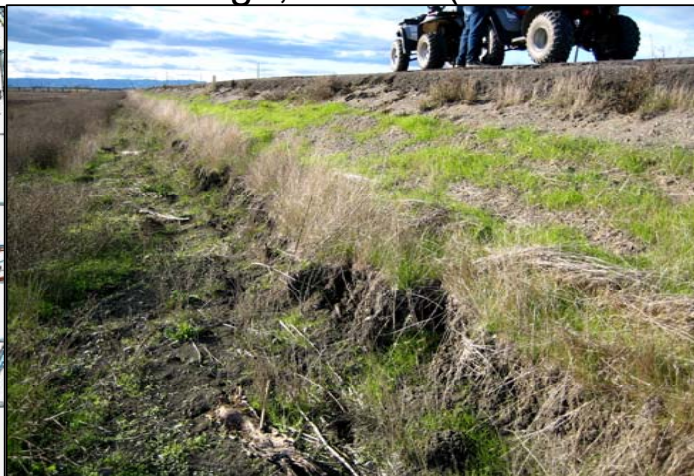
Willow Slough, LM 0.6 (DWR Unit 1 North)

Criteria	Score	Notes
Bank Slope (*2)	3	1.5:1 slope
Berm Width (*2) - Estimated	5	no berm
Location of erosion	0	upper levee slope
Bank Stability	2	short vertical sections
Site Relative to Bend	1	straight
Vegetation Cover	2	50%
Tree Hazard	0	no trees
Soil Type (*2)	2	clays and silts
Velocity (*2)	0	0.5 ft/s
Human Usage	2	seasonal for duck hunting
Erosion Hazard	27	Calculate Erosion Hazard

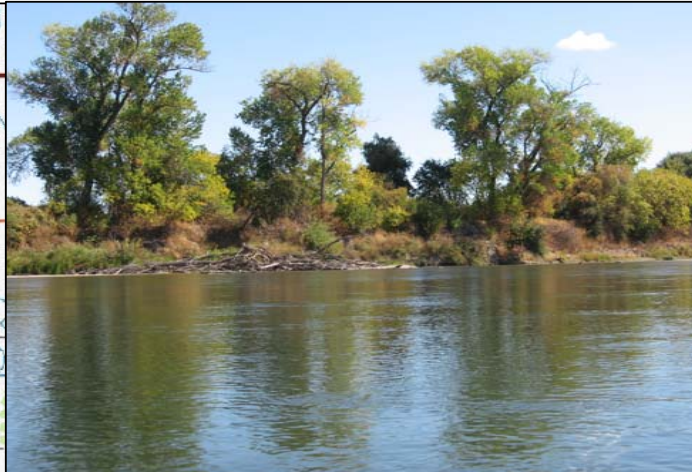
Sacramento River, RM 168.3L

Criteria	Score	Notes
Bank Slope (*2)	1	2.5:1 slope
Berm Width (*2) - Estimated	0	30 ft
Location of erosion	3	toe
Bank Stability	0	no vertical sections or caves
Site Relative to Bend	1	straight
Vegetation Cover	1	60 to 70%
Tree Hazard	3	large trees
Soil Type (*2)	4	sand and silts (sand deposited)
Velocity (*2)	3	4.81 ft/s
Human Usage	2	seasonal
Erosion Hazard	26	Calculate Erosion Hazard

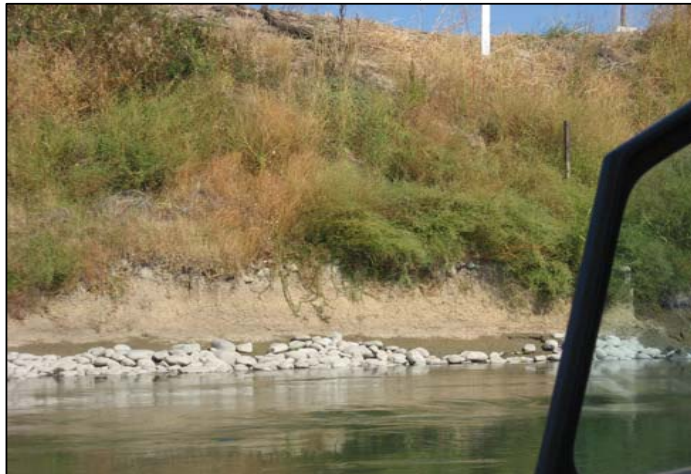
Sacramento River, RM 104.5L

Criteria	Score	Notes
Bank Slope (*2)	3	1.5:1 slope
Berm Width (*2) - Estimated	0	40 ft
Location of erosion	4	berm and toe
Bank Stability	0	no vertical sections or caves
Site Relative to Bend	4	outside of a 90 degree bend
Vegetation Cover	1	70%
Tree Hazard	0	no trees
Soil Type (*2)	4	sands and silts
Velocity (*2)	1	1.68 ft/s
Human Usage	1	occassional
Erosion Hazard	26	Calculate Erosion Hazard

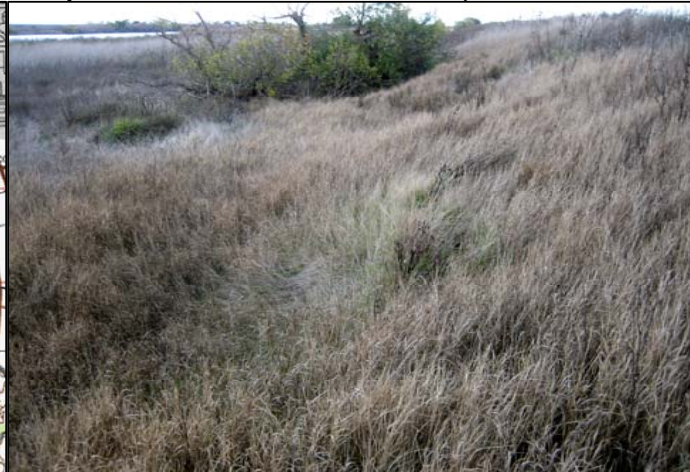
Deep Water Ship Channel, LM 5.01 (RD 999 Unit 1 East)

Criteria	Score	Notes
Bank Slope (*2)	2	2:1 slope
Berm Width (*2) - Estimated	5	no berm
Location of erosion	1	levee slope
Bank Stability	0	no bvertical sections or caves
Site Relative to Bend	1	straight
Vegetation Cover	1	lots of grass, some shrubs, 80%
Tree Hazard	2	medium tree
Soil Type (*2)	2	clays and silts
Velocity (*2)	1	1.3 ft/s
Human Usage	0	rare
Erosion Hazard	25	Calculate Erosion Hazard

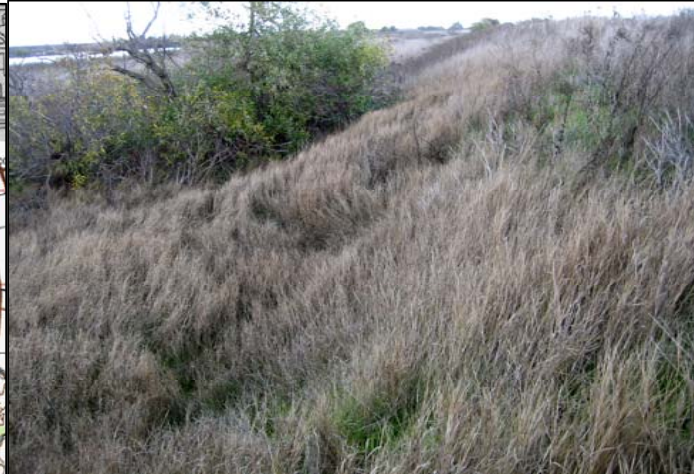
Site Photograph

Criteria	Score	Notes
Bank Slope (*2)	2	2:1 slope
Berm Width (*2) - Estimated	5	no berm
Location of erosion	1	levee slope
Bank Stability	0	no bvertical sections or caves
Site Relative to Bend	1	straight
Vegetation Cover	1	lots of grass, some shrubs, 80%
Tree Hazard	2	medium tree
Soil Type (*2)	2	clays and silts
Velocity (*2)	1	1.3 ft/s
Human Usage	0	rare
Erosion Hazard	25	Calculate Erosion Hazard

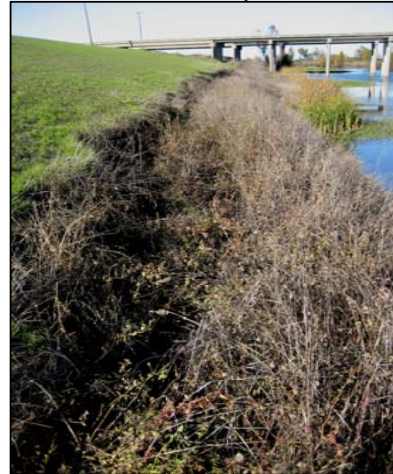
Site Photograph

Criteria	Score	Notes
Bank Slope (*2)	0	3:1 slope
Berm Width (*2) - Estimated	5	no berm
Location of erosion	4	toe and lower slope
Bank Stability	2	vertical sections, less than half bank height
Site Relative to Bend	1	straight
Vegetation Cover	1	70%
Tree Hazard	0	no trees
Soil Type (*2)	2	clays and silts
Velocity (*2)	1	1.5 ft/s
Human Usage	1	occassional
Erosion Hazard	25	Calculate Erosion Hazard

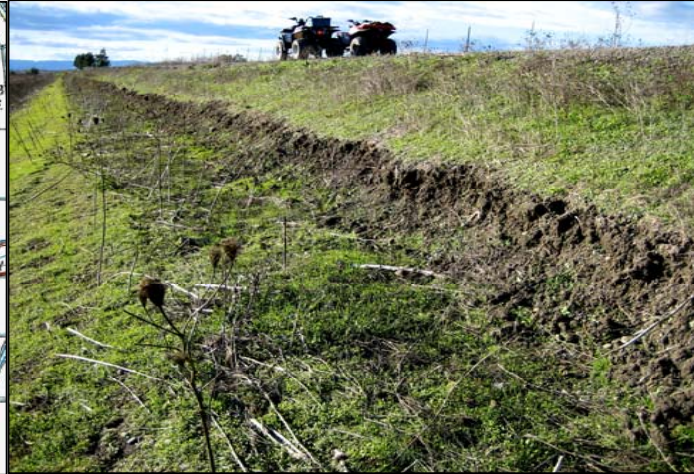
Site Photograph

Criteria	Score	Notes
Bank Slope (*2)	2	2:1 slope
Berm Width (*2) - Estimated	5	no berm
Location of erosion	1	mid levee slope
Bank Stability	2	short vertical sections
Site Relative to Bend	1	straight
Vegetation Cover	1	80%
Tree Hazard	0	no trees
Soil Type (*2)	2	slits and clays
Velocity (*2)	0	0.6 ft/s
Human Usage	2	season, frequent for Duck Hunters
Erosion Hazard	25	Calculate Erosion Hazard

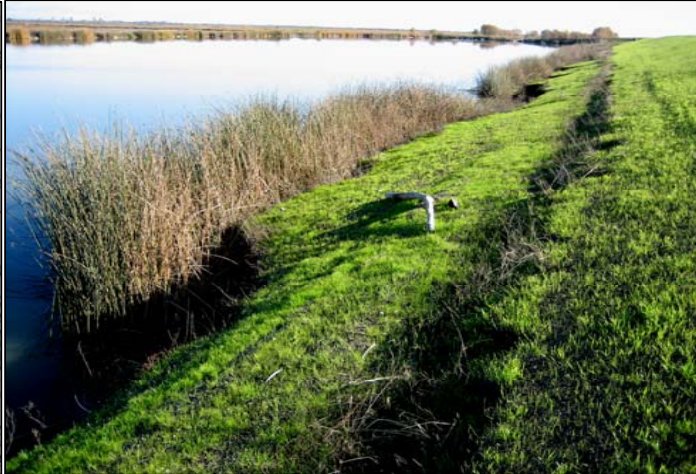
Site Photograph

Criteria	Score	Notes
Bank Slope (*2)	0	3:1 slope
Berm Width (*2) - Estimated	5	no berm
Location of erosion	4	toe and lower slope
Bank Stability	2	vertical sections, less than half bank height
Site Relative to Bend	1	straight
Vegetation Cover	0	80 to 90 %
Tree Hazard	0	no trees
Soil Type (*2)	2	clays and silts
Velocity (*2)	1	1.5 ft/s
Human Usage	1	occassional
Erosion Hazard	24	Calculate Erosion Hazard

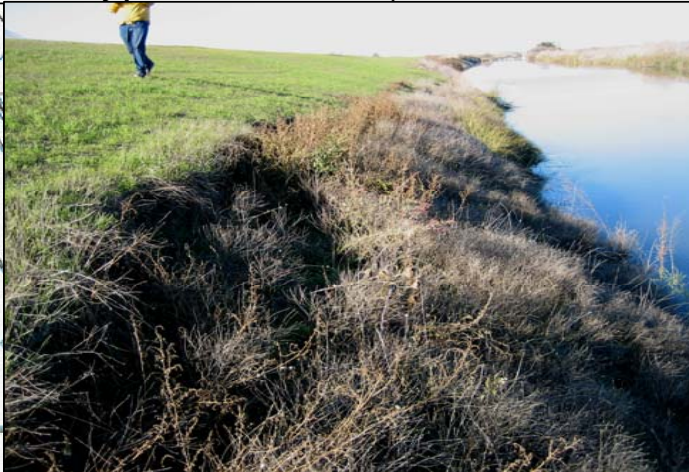
Site Photograph

Criteria	Score	Notes
Bank Slope (*2)	0	3:1 slope
Berm Width (*2) - Estimated	5	no berm
Location of erosion	4	toe and lower slope
Bank Stability	2	vertical sections, less than half bank height
Site Relative to Bend	1	relatively straight
Vegetation Cover	0	90%
Tree Hazard	0	no trees
Soil Type (*2)	2	clays and silts
Velocity (*2)	1	1.5 ft/s
Human Usage	1	occassional
Erosion Hazard	24	Calculate Erosion Hazard

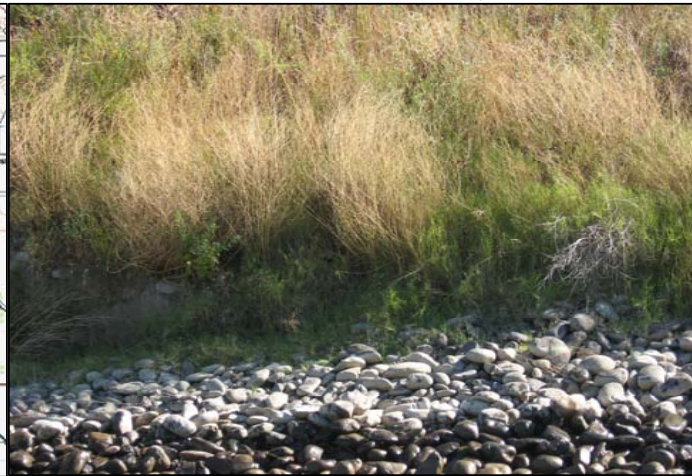
Site Photograph

Criteria	Score	Notes
Bank Slope (*2)	3	1.5:1 slope
Berm Width (*2) - Estimated	0	30 ft
Location of erosion	2	lower bank
Bank Stability	0	no vertical sections or caves
Site Relative to Bend	1	straight
Vegetation Cover	1	70%
Tree Hazard	0	no trees
Soil Type (*2)	2	clays and silts
Velocity (*2)	3	4.91 ft/s
Human Usage	2	seasonal
Erosion Hazard	22	Calculate Erosion Hazard

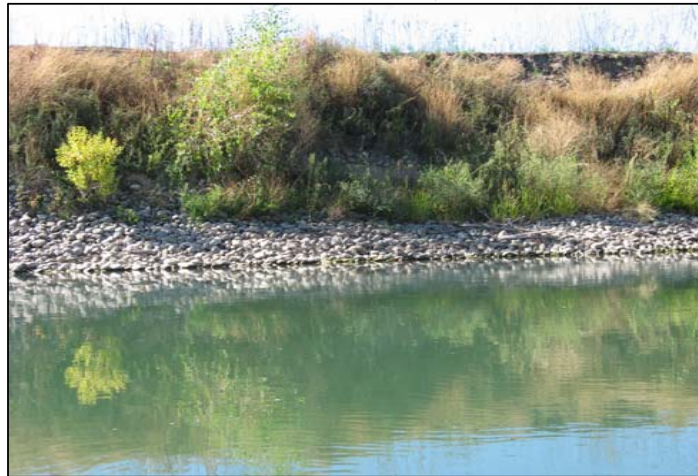
Site Photograph

Criteria	Score	Notes
Bank Slope (*2)	2	2:1 slope
Berm Width (*2) - Estimated	0	30 ft
Location of erosion	2	lower bank
Bank Stability	2	vertical sections less than half bank height
Site Relative to Bend	2	just downstream of a bend
Vegetation Cover	2	60%
Tree Hazard	0	no trees
Soil Type (*2)	1	clays and rounded stone
Velocity (*2)	3	4.97 ft/s
Human Usage	2	seasonal
Erosion Hazard	22	Calculate Erosion Hazard

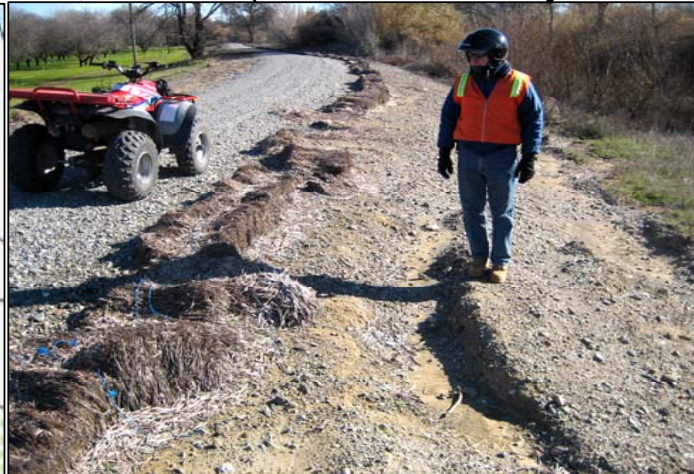
Site Photograph

Criteria	Score	Notes
Bank Slope (*2)	2	2:1 slope
Berm Width (*2) - Estimated	2	10 ft
Location of erosion	0	upper levee slope
Bank Stability	0	no vertical sections or caves
Site Relative to Bend	1	relatively straight
Vegetation Cover	1	minimal in erosion area, 80% coverage on remaining land
Tree Hazard	2	medium trees
Soil Type (*2)	2	clays and gravels
Velocity (*2)	2	3 ft/s
Human Usage	2	seasonal
Erosion Hazard	22	Calculate Erosion Hazard

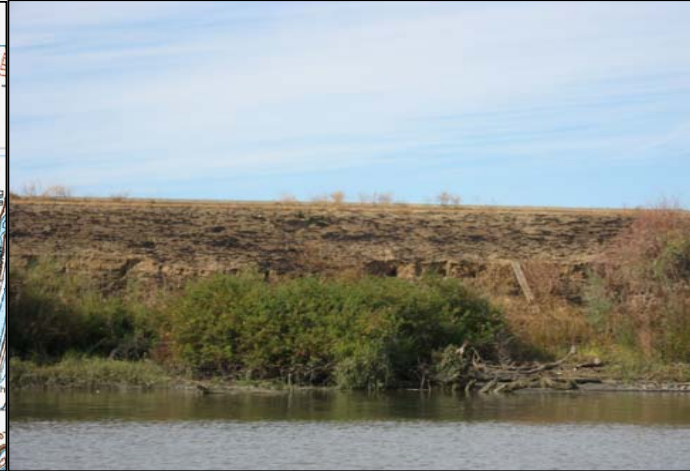
Site Photograph

Criteria	Score	Notes
Bank Slope (*2)	2	2:1 slope
Berm Width (*2) - Estimated	0	no berm
Location of erosion	4	toe and lower bank
Bank Stability	2	some vertical sections, less than half bank slope
Site Relative to Bend	2	just downstream of a bend
Vegetation Cover	2	blotchy coverage, dense in spots, 50%
Tree Hazard	0	no trees
Soil Type (*2)	2	clay and silts
Velocity (*2)	0	0.27 ft/s
Human Usage	3	adjacent to levee road, monthly
Erosion Hazard	21	Calculate Erosion Hazard

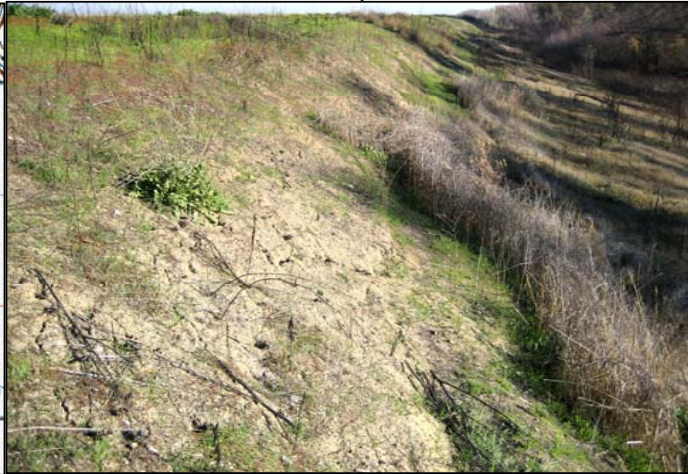
Site Photograph

Criteria	Score	Notes
Bank Slope (*2)	3	1.5:1 slope
Berm Width (*2) - Estimated	0	40 ft of berm
Location of erosion	4	toe and lower slope
Bank Stability	0	no vertical sections or caves
Site Relative to Bend	1	straight
Vegetation Cover	2	50%
Tree Hazard	0	no trees
Soil Type (*2)	2	silts with clays
Velocity (*2)	1	1.5 ft/s
Human Usage	1	occassional
Erosion Hazard	20	Calculate Erosion Hazard
